Codding Farm Barn: Reuse and Rehabilitation Feasibility Report

Reuse and Rehabilitation
Feasibility Report

Community Partner:
North Attleborough Historical Commission

Fall 2013

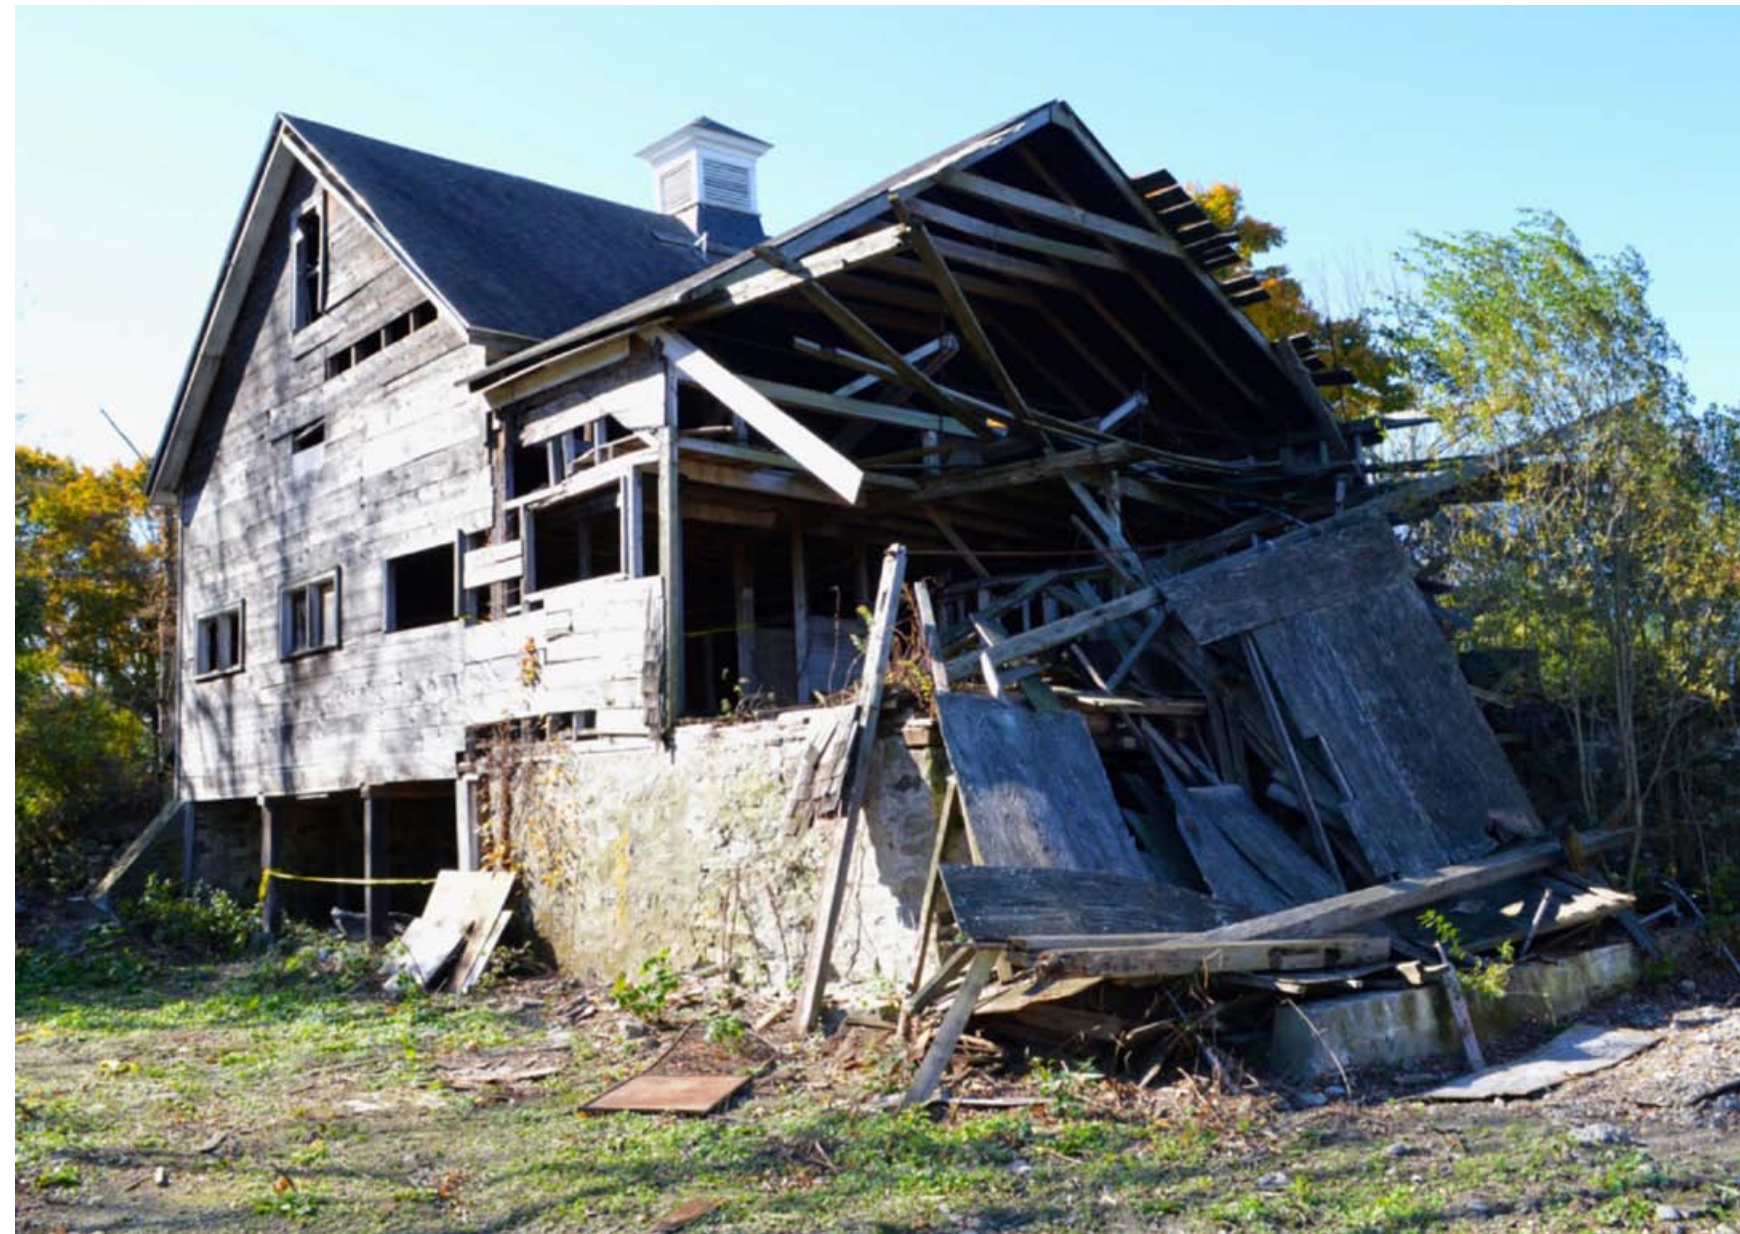
The collapsed northern section of the barn has let the interior become more vulnerable to the elements.

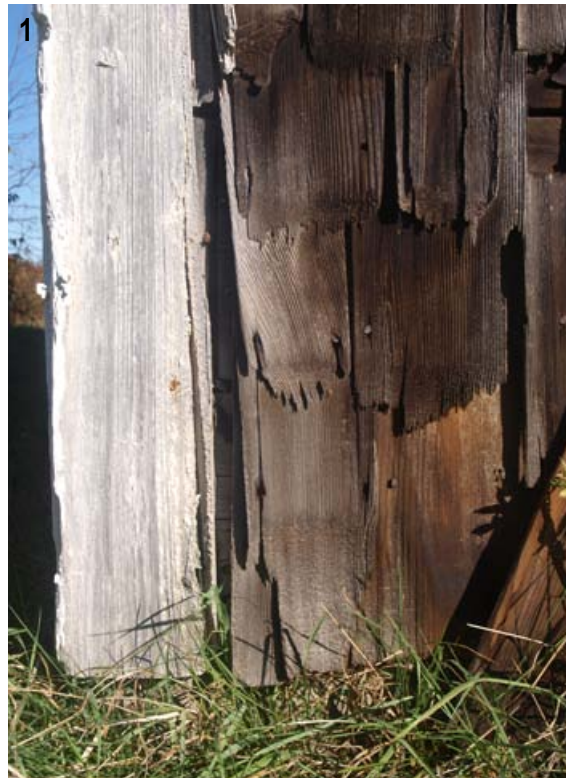
The decorative painted wood trim is original. The trim is flat and plain in design. The wood has weathered and is in need of some repairs and fresh paint.

1. The original decorative trim is weathered and in need of repair.
2. The disintegrating fascia on the east elevation; the soffit is hanging on with just a few nails.
3. The new asphalt roof and the cupola are in good condition.

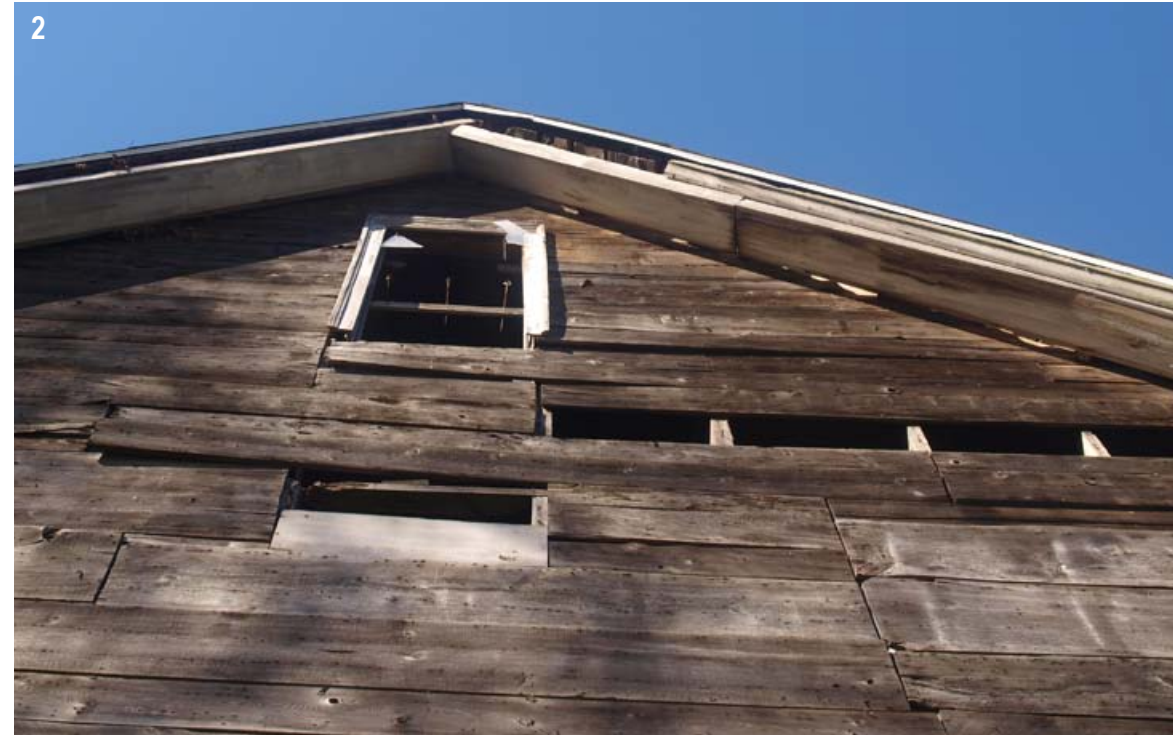
The fascia and soffit were examined from ground level since no ladder was available for a full examination. They are painted wood and have experienced minimal alteration. However, they are in extremely poor condition on the east elevation where the soffit has started to fail, disintegrate and is precariously hanging by just a few nails.

- **8.2.5.** The fascia and soffit on the east elevation will be secured back into place if the material integrity of the wood is sound. If these elements need to be replaced, they will be made to match the fascia and soffit on the west elevation.

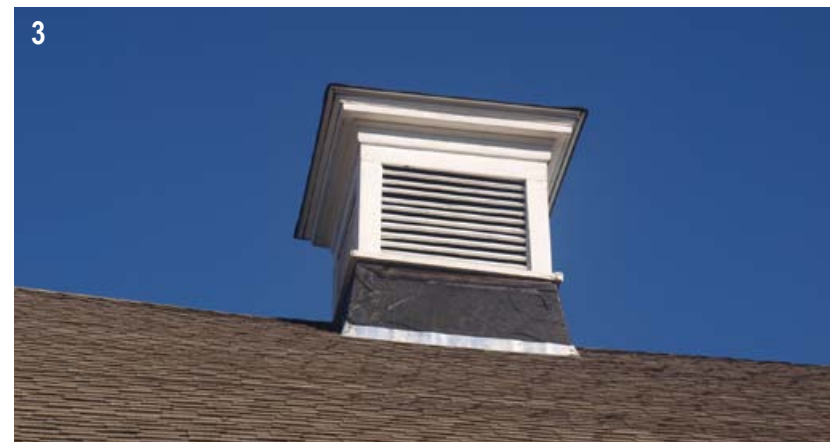
The roofing is in very good condition; it is not original. After the North Attleborough Historical Commission came into possession of the barn, the roof was replaced. The roofing material is asphalt shingles. This is not the material that would have been used originally, but the roof is watertight.

The cupola also appears to have been preserved during the roofing process and is in good condition with minimal to no weathering damage. The base of the cupola was never finished with cedar shingles, thus leaving the waterproofing membrane exposed.

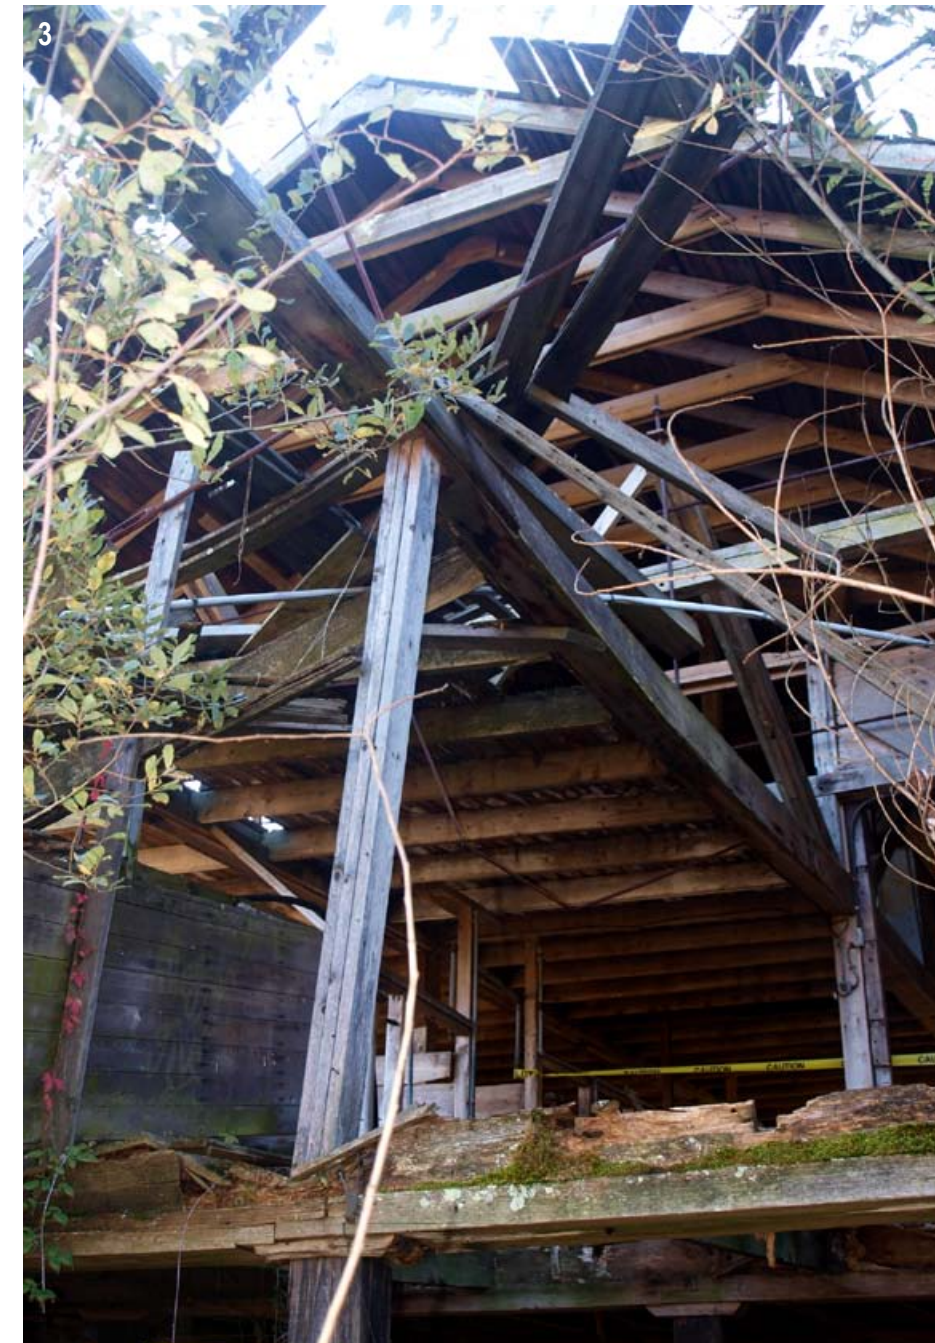
1. West elevation window covered with metal wire mesh.
2. Many of the structural beams are rotting away and need to be replaced.
3. The collapsed north elevation is precariously balanced on a crooked wooden column.

1.1. Existing Conditions: The north elevation structure has collapsed and compromises both the structural integrity and longevity of the still extant portion of the barn.

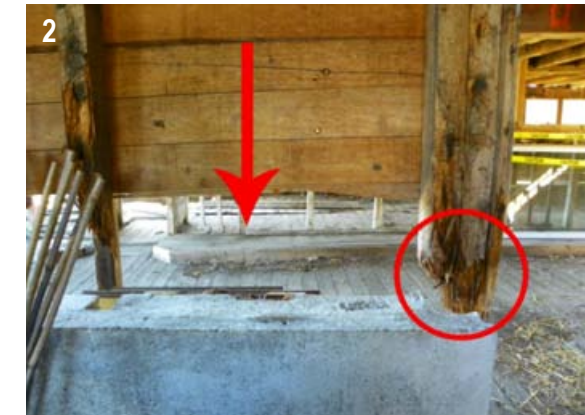
missing and large portions of rot and termite damage. There is much paint failure, and graffiti is also present.

2. Walls show rot and termite damage.

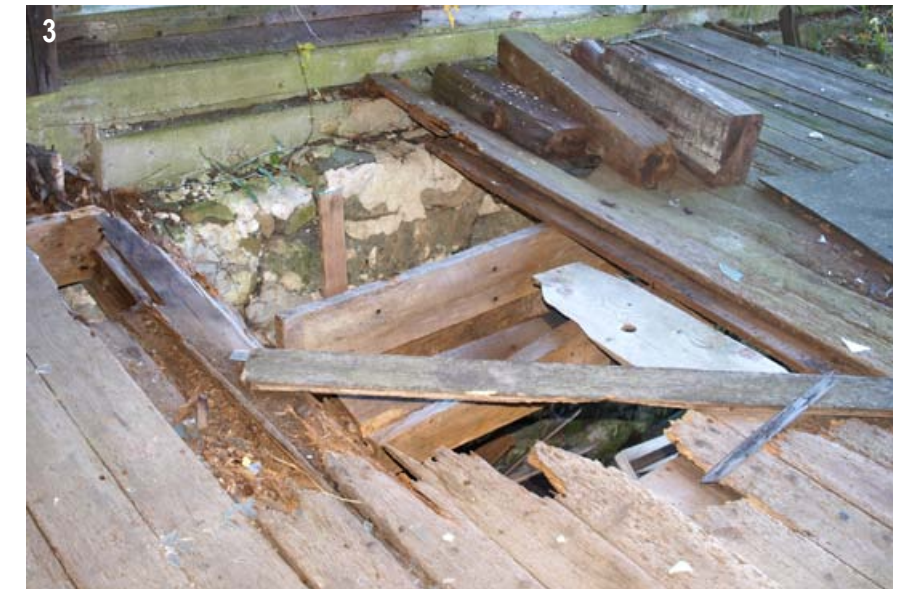
The floors can be divided into three identifying sections: the section taped off by the north elevation; the section adjacent to the east elevation where the cows stood; and the rest of the floor. The first two sections are in poor condition. Due to the north elevation wall falling down, much of the floor is missing, making the area completely unsafe for walking. Even in the areas that do have flooring, there are large gaps where floor boards have rotted away.

The section adjacent to the east elevation is also unsafe. This area contained the trough for the cows, and the entire trough is rotted out. Also, several boards are missing or rotted. The rest of the flooring is in better condition. It contains some rotted out areas and missing boards, but overall it is in fair condition.

3. Large sections of flooring have been broken or rotted away.

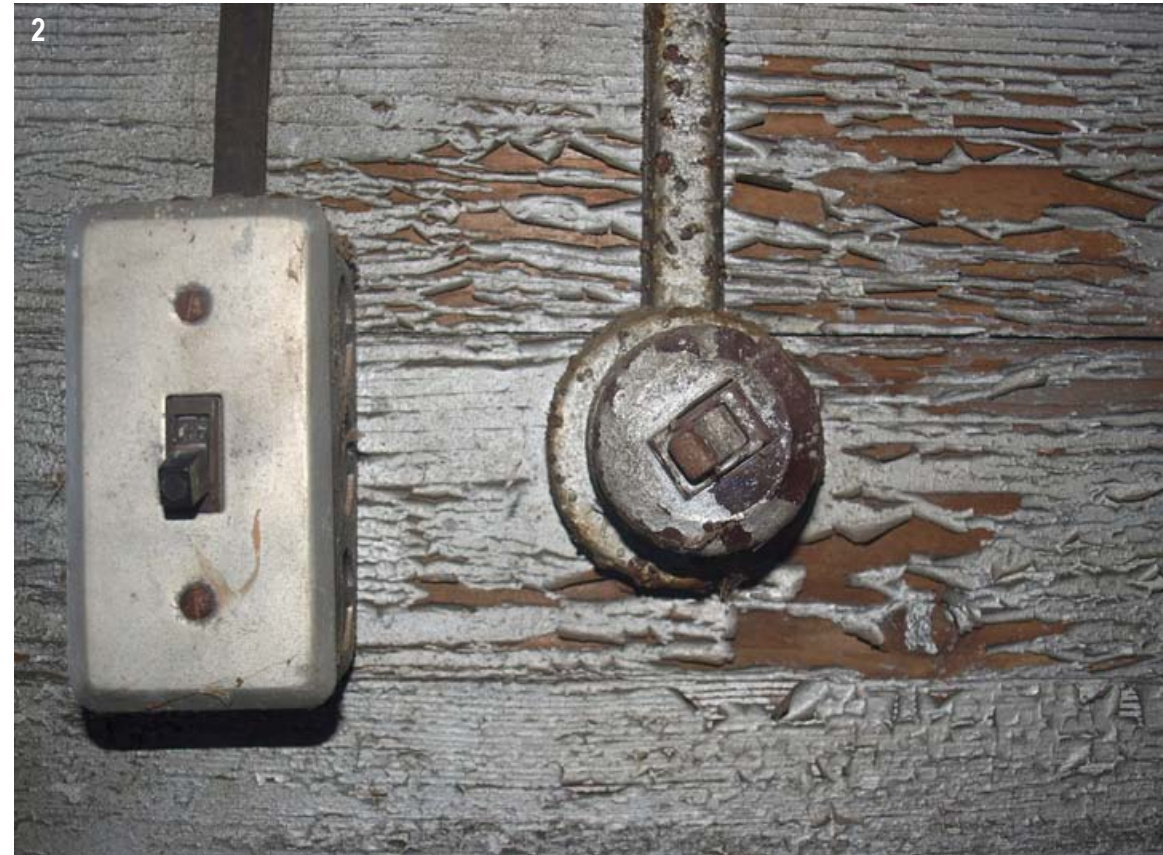
Some original hardware remains extant in the barn such as hinges and door knobs, although most are extremely rusted.

1. Some original hardware remains, although it is extremely rusted.

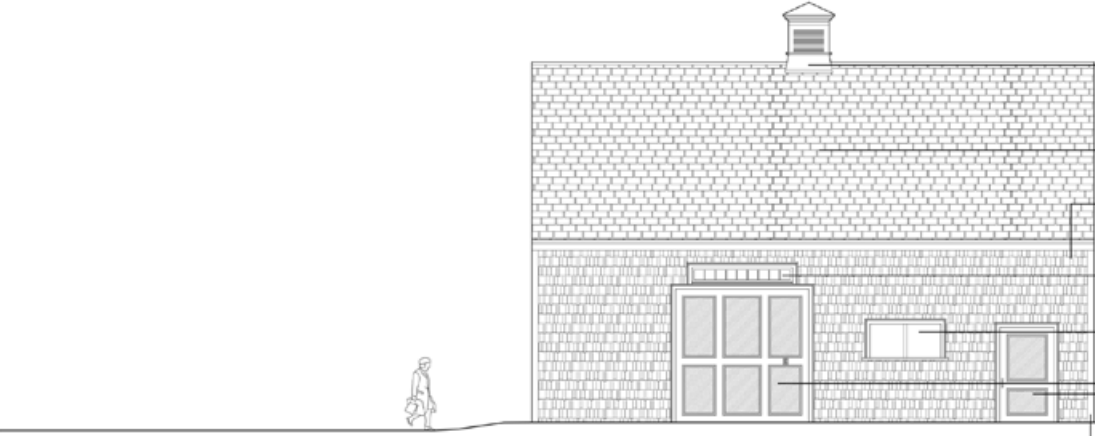
SOUTH ELEVATION

CUPOLA IS MISSING CEDAR SHINGLES ON ALL ELEVATIONS; WATERPROOFING MEMBRANE IS EXPOSED

ASPHALT SHINGLE ROOF IS IN GOOD CONDITION

CEDAR SHINGLES ARE BROKEN, WEATHERED, AND MISSING

TRANSOM WINDOW GLASS IS BROKEN

WINDOW IS MISSING SASH

DOORS ARE IN GOOD CONDITION AND RETAIN ALL ORIGINAL DETAILING

TRIM IS IN GOOD CONDITION; SOME AREAS OF ROT NEAR GROUND

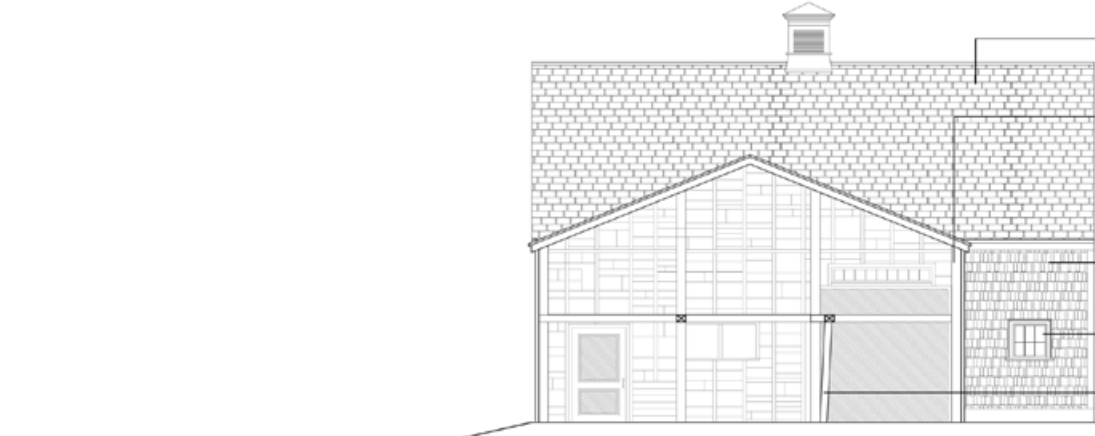
NORTH ELEVATION

ASPHALT SHINGLE ROOF IS IN GOOD CONDITION

CEDAR SHINGLES ARE BROKEN, WEATHERED, AND MISSING

FRAME AND SASH REMAIN; GLASS AND GLAZING ARE IN POOR CONDITION

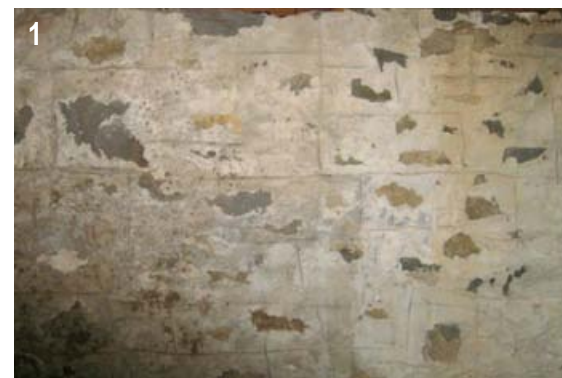
2.1. Existing Conditions: The fieldstone foundation wall was top-coated with plaster, but

portions of this finish are missing, and some stones have become loose in the mortar. There is also damage from moisture in terms of bio-growth.

1. A detail of the original rubble stone foundation – the top coating has been scored to resemble a more regular stone block.

- **2.2.1.** Bio-growth will be removed from the stones using a biocide compound.
- **2.2.2.** Remaining plaster will be carefully removed from the south and west walls, but the best portion of the finish on the east wall will be preserved to illustrate the plastering technique and scored pattern.
- **2.2.3.** The stone foundation wall will be re-pointed using a historically authentic lime mortar, paying careful attention to the areas in which the mortar has failed. Missing stones will be replaced as part of this process.

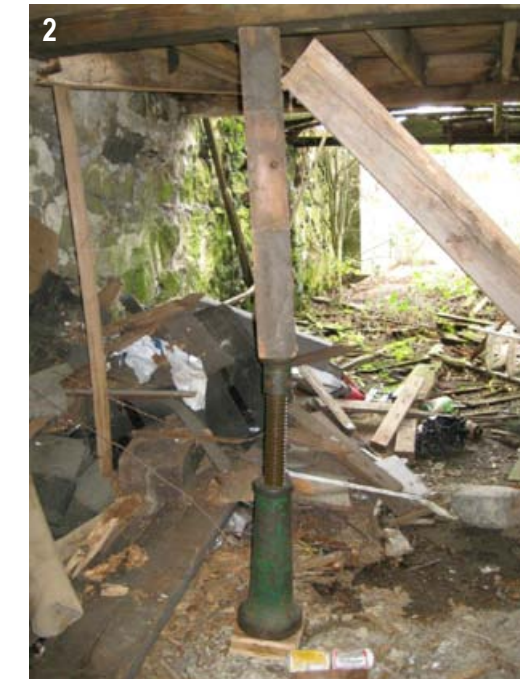
4.1. Existing Conditions: The primary wood columns and secondary wall studs show a variety of conditions. Most notably, the columns at the foundation level have been cut to remove rotted portions and are now supported by concrete footings. The columns on the first floor level have been reinforced with additional pieces of wood. An additive process of building up the structure is evident, although it is not clear if this is

2. The columns at foundation level need to be replaced. The temporary jacks are not on level ground.

- **4.2.1.** The columns at the foundation level will be removed and replaced with new material or salvaged pieces of the proper length. The obtrusive concrete footings will be removed.
- **4.2.2.** Vertical structural members at the first floor level will be replaced with wooden columns that are dimensioned to support the structure without added pieces and patches of wood.

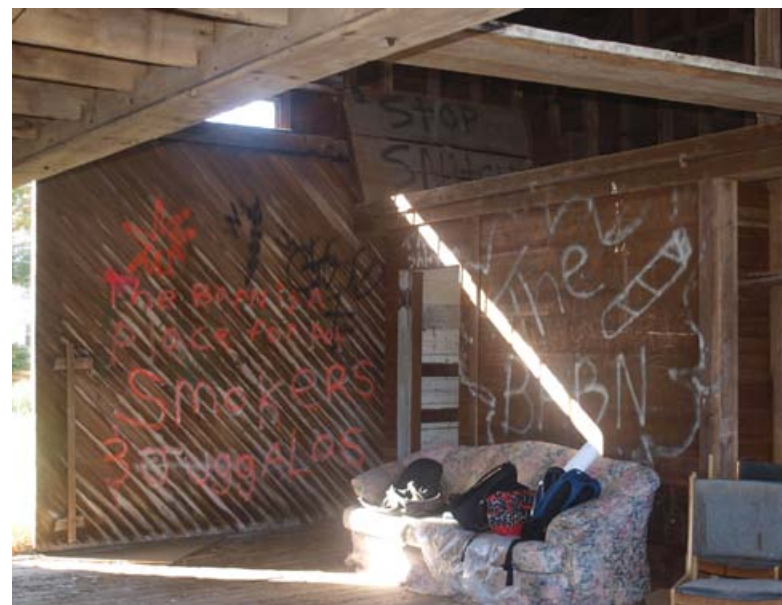
7.1. Existing Conditions: The south elevation on the first floor level has some extant interior wood paneling in fair condition, but the majority of the finish is missing. The interior walls of the main space on the first floor towards the west are also paneled in good condition with a natural finish, but some are broken and missing at the far north end. The walls of the dairy wash-out room and service space are wood paneled in good condition in terms of material integrity, but the paint finish is in poor condition. All of the wood paneling has been marked by graffiti.

The graffiti marking the wood paneling on many of the interior walls will be removed.

- **7.2.1.** Wood paneling that is not painted will be sanded to remove the graffiti paint as well as smooth out any scratches and etches left by vandals.
- **7.2.2.** Wood paneling that is missing or severely damaged will be patched or replaced with new wooden boards of the same type, texture and dimension. This will be done so there are no obvious vertical seams, especially towards the north end.
- **7.2.3.** Wood paneling that is painted will be tested for lead levels; if the tests return positive, additions will be added to the scope of work to safely abate the potentially hazardous material.
- **7.2.4.** Painted wood paneling will be hand washed to remove grime and loose flakes of paint, then sanded to create a smooth surface. Lastly, the wood will be repainted for a fresh finish.
